RESEARCH DEPARTMENT

ACOUSTIC TESTS ON THE WALKER MEMORIAL HALL, BIRMINGHAM

Technological Report No. B-089/1
UDC 534.861.1 1966/4

February 1966

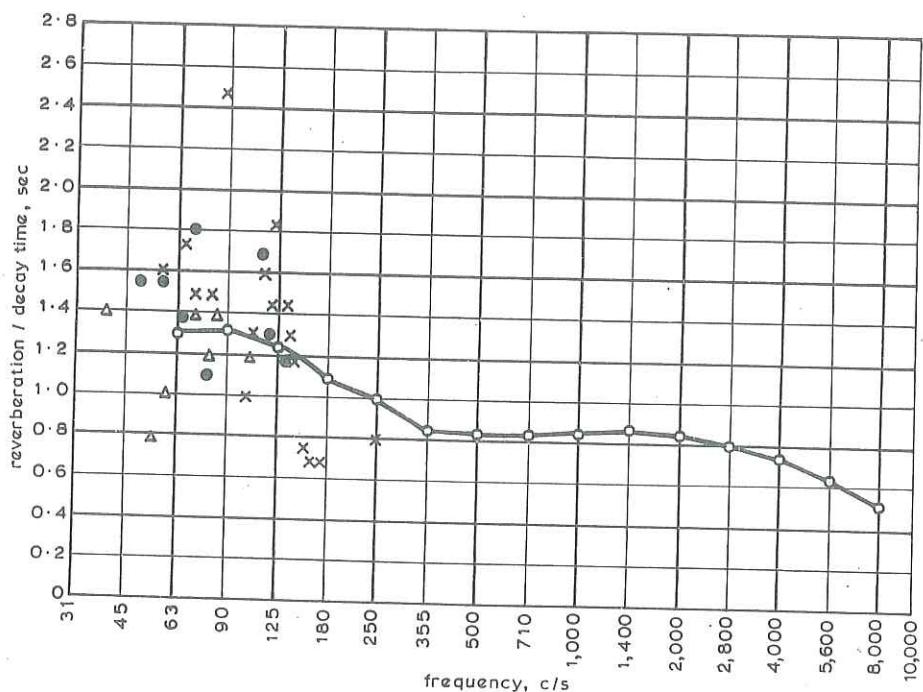
Fig. 1 - Measurements before modification

Fig. 1 shows the reverberation curve of the hall before alteration. There was a steep rise at low frequencies, reaching 1.3 sec at 90 c/s. There was also a general maximum centred on 1400 c/s. The high reverberation times at low frequencies were associated in many cases with marked double decays. There were long rings heard when pulsing the studio with tone of frequencies up to 1 kc/s or more, apparently associated with the maximum of the curve in this region. These rings were found to be connected with standing-wave systems between the floor and ceiling. They could be treated by absorbers mounted on the ceiling.

was attached to various points on the floor and the hall again excited by tone from the loudspeaker. The decay times were measured at every frequency at which there was a maximum of floor vibration. Two groups of accelerometer positions were chosen, one group on the centre line between two sleeper walls and the other over the sleeper walls. The decay times are plotted in Fig. 1 against the frequencies of maximum resonance. It will be seen that the points are all in the region of maximum room reverberation time and that many are well above the reverberation curve.

The relationship between the floor measurements and the reverberation curve was taken as a strong indication that floor resonances accounted for the double-slope decays observed in the reverberation measurements, and therefore for the subjective "boominess" of the studio when used for music. The most important recommendation was therefore that the floor should be stiffened and effectively damped.

The optimum reverberation time for the volume of 12,200 ft³ (346 m³) is approximately 0.75 sec.

About 350 ft² (32.5 m²) of bonded bass or equivalent absorbers would be required to reduce the low-frequency reverberation to this time and the high frequency reverberation should be increased by the removal of the curtains.

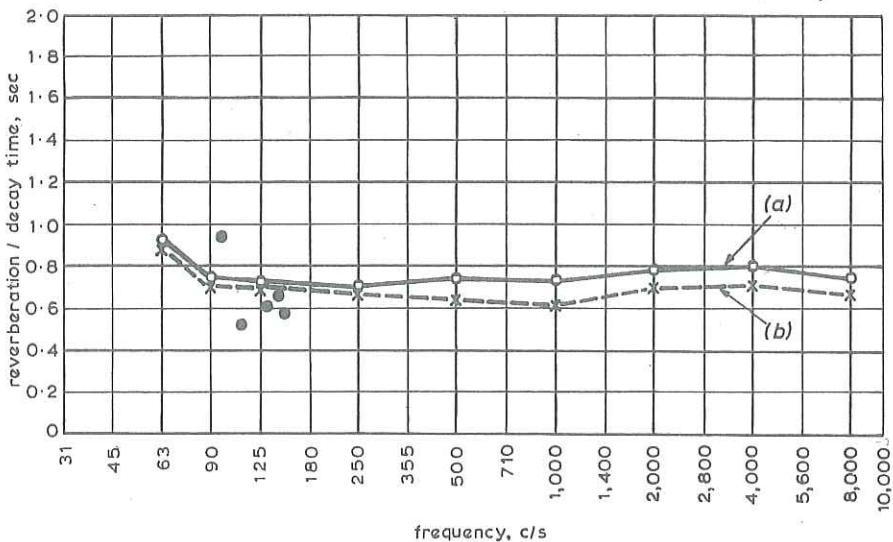
Fig. 2 - Measurements after modification

Subsequent tests were conducted on October 14th 1965, the studio being in the condition described above, except that the stage and curtains were absent. The measured reverberation-time curve is displayed in Fig. 2(a) and shows a close correspondence with the design value of 0.75 secs. Curve 2(b) is included in the figure to show the expected changes caused by the addition of the stage curtains in a "run-back" position. The slight

increase in reverberation times at frequencies above 1 kc/s was noticeable subjectively, the studio having a rather "bright" sound.

Accelerometer measurements of the vibration of the floor are included in Fig. 2 and show that the modifications to its structure have been successful in eliminating the high Q of the resonances. All floor vibration decay times are now shorter than, or comparable with, the room reverberation time, and the previously observed colourations due to the floor cannot be heard.

2. The acoustics of the studio and cubicle are likely to be satisfactory, except that it will probably be necessary to increase the absorption in the studio above 1 kc/s.

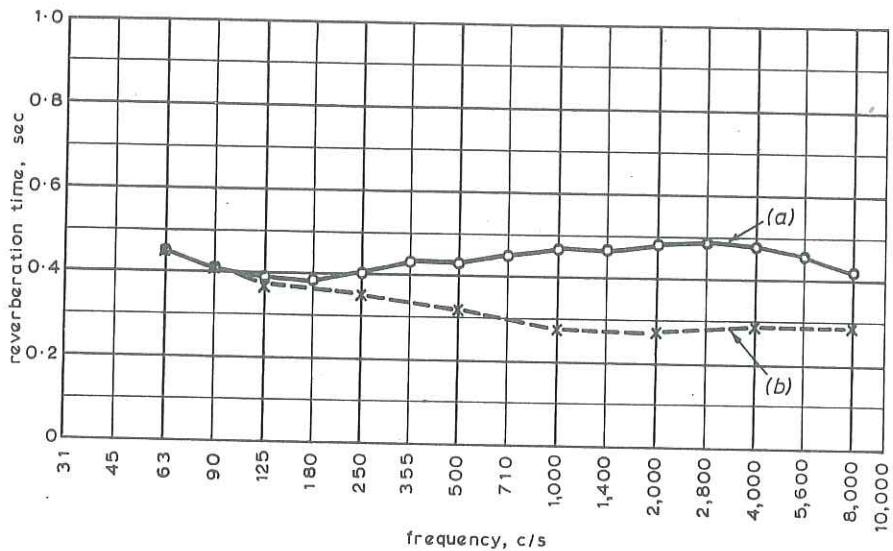
Fig. 3 - Reverberation time of cubicle

Since building operations were still in progress it was not possible to conduct measurements of the transmission losses through the observation window because of the presence of many flanking paths through un-plugged cable ducts, etc. The reverberation time curve for the cubicle is plotted in Fig. 3(a) which, due to the absence of the carpet and console etc. is slightly in excess of the design figure of 0.3 secs. A corrected curve (3(b)) which includes the expected absorption of the carpet, is included in this figure; it shows close agreement with the original design calculations which included the effect of the carpet.
